PARK ROAD - ROAD SAFETY AUDIT (RSA)

Quaker Lane South to Prospect Avenue

RSA Date: October 24, 2023

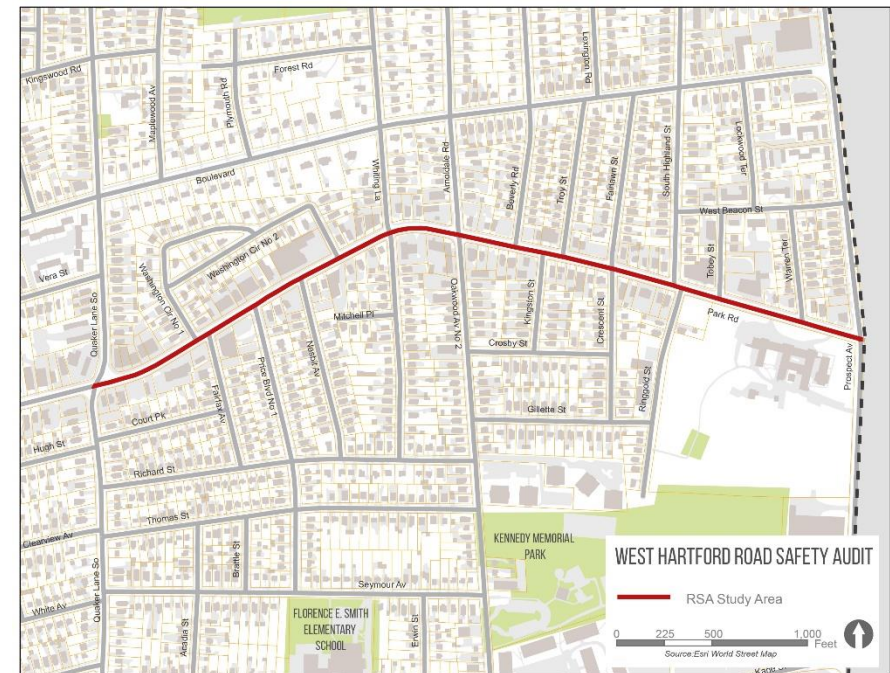
Exhibit 1-1: Road Safety Audit (RSA) Study Area

The study area for this RSA is shown in Exhibit 1-1.

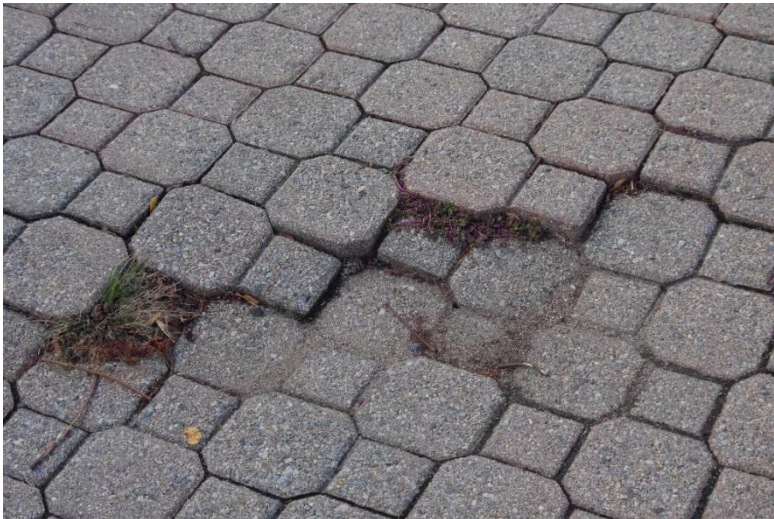
Exhibit 3-1: Typical surface conditions in some areas of the study area on the brick paver sidewalk.

- Pedestrian accommodations and crossings throughout the study area.
- Bicycle accommodations throughout the study area
- Poor roadway and sidewalk surface condition throughout the study area. See Exhibit 3-1.
- Roadway pavement marking condition is missing or is in poor condition throughout the study area.
- Very limited speed limit signage throughout the study area.
- Parked vehicles hinder sightlines to driveways, intersections, and crosswalks throughout the study area due to parking close to these areas.

- Upgrades to bring study area into ADA compliance. Note this work is currently underway by the Town as part of the grant received by the state. This includes:
 - Curb ramp improvements
 - Sidewalk surface improvements to remove tripping hazards, particularly at driveways
 - Pedestrian signal equipment at traffic signals and RRFBs.
- Improved pedestrian lighting, particularly on the south side of Park Road. The Town is currently implementing a lighting project which will address much of these lighting concerns.

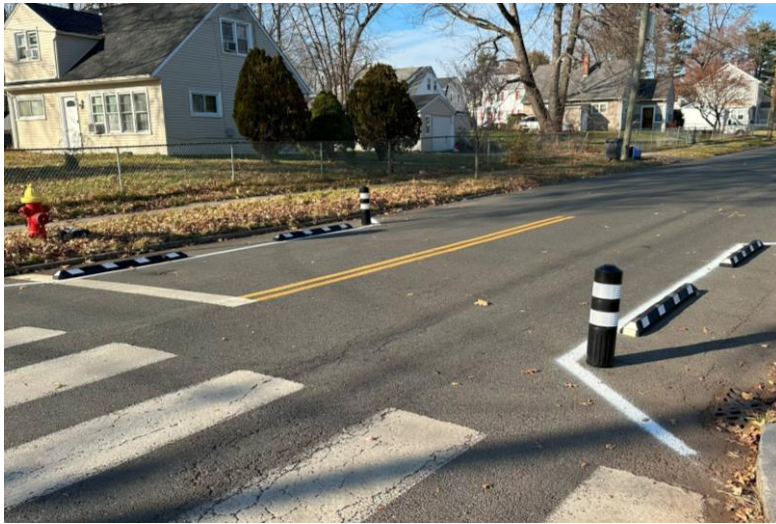
Exhibit 3-2: Example of quick-build bumpout which can discourage parking close to intersections.

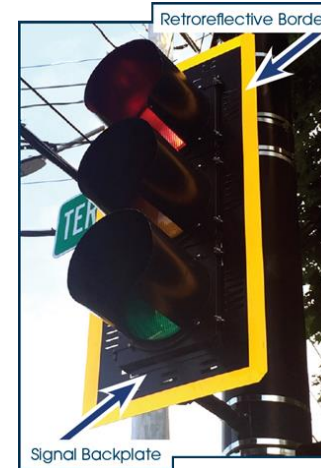
Exhibit 3-3: Example of retroreflective backplate (Source: FHWA)

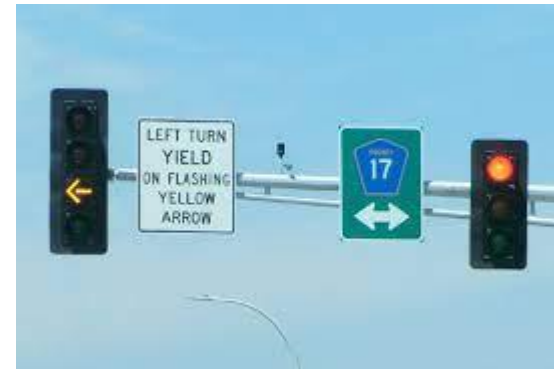
Exhibit 3-4: Example of Flashing Yellow Arrow (FYA) (Source: FHWA)

- Flashing Yellow Arrow (FYA) on all protected-permitted left-turn signal heads in study area. This is found to reduce injury crashes approximately 22% and left-turn related crashes between 38 to 50%. Refer to Exhibit 3-4 for an example.

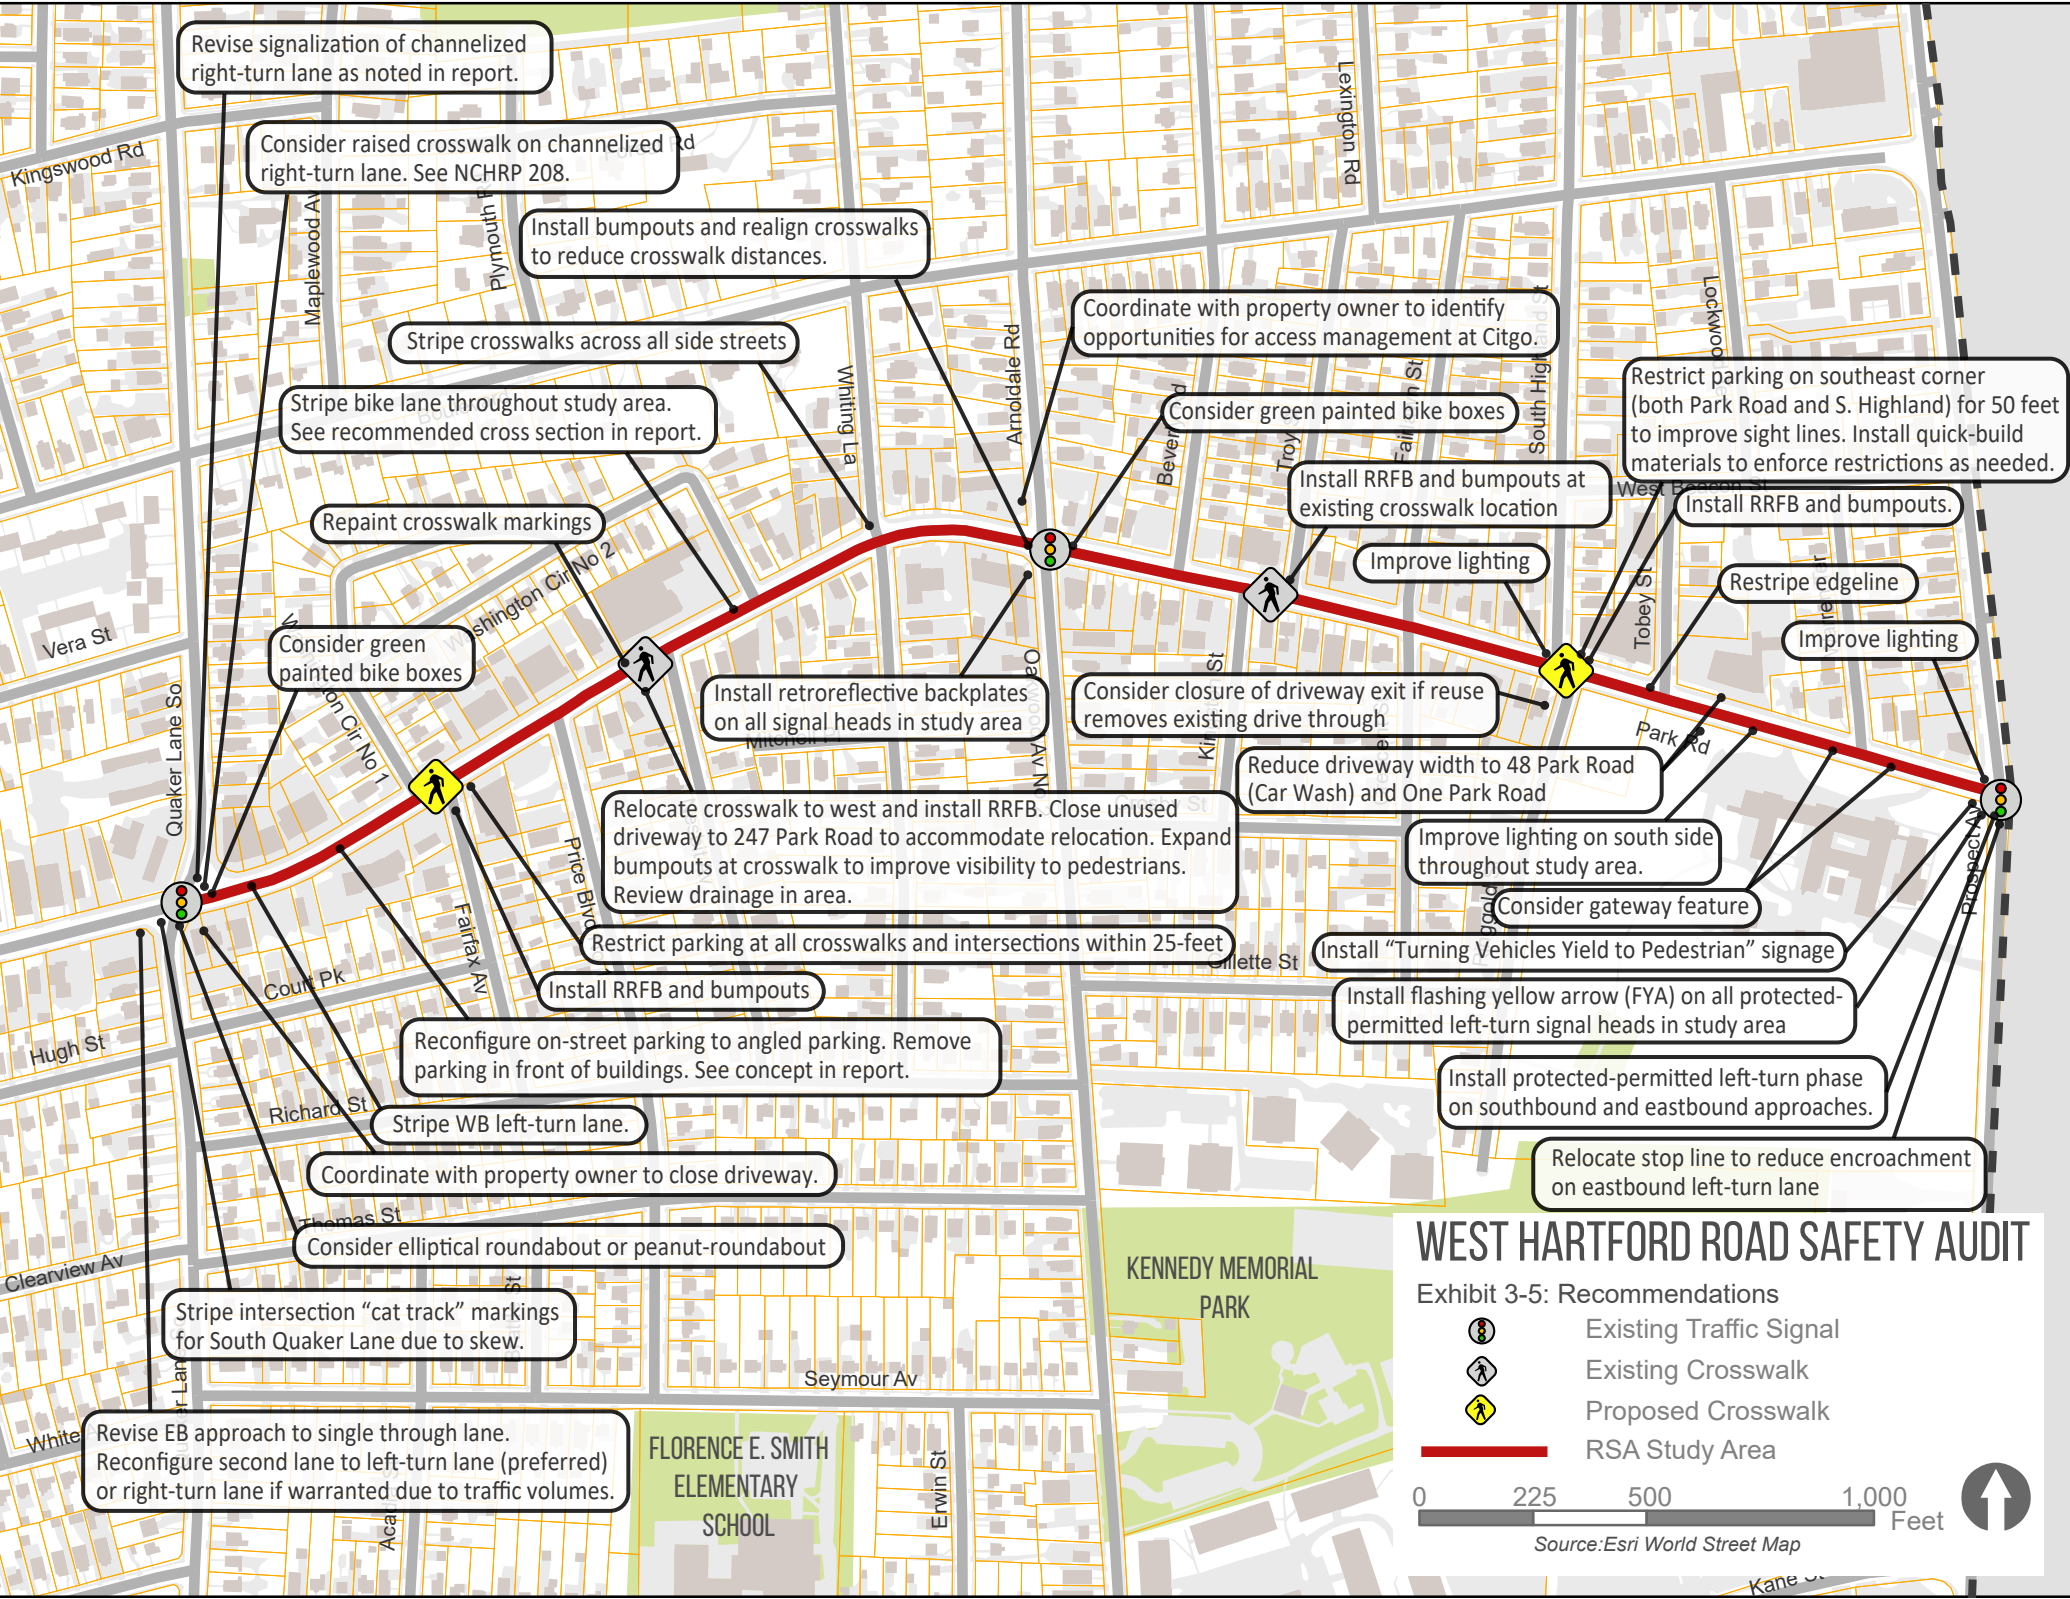
Exhibit 3-5: Recommendations

Revise signalization of channelized right-turn lane as noted in report.

Consider raised crosswalk on channelized right-turn lane. See NCHRP 208.

Stripe bike lane throughout study area. See recommended cross section in report.

- Two additional crosswalk locations are recommended. This reduces the distance between crosswalks to an average of 680-feet. Refer to Exhibit 3-5 for a location of crosswalks at traffic signals and other locations. The two proposed crosswalk locations include:

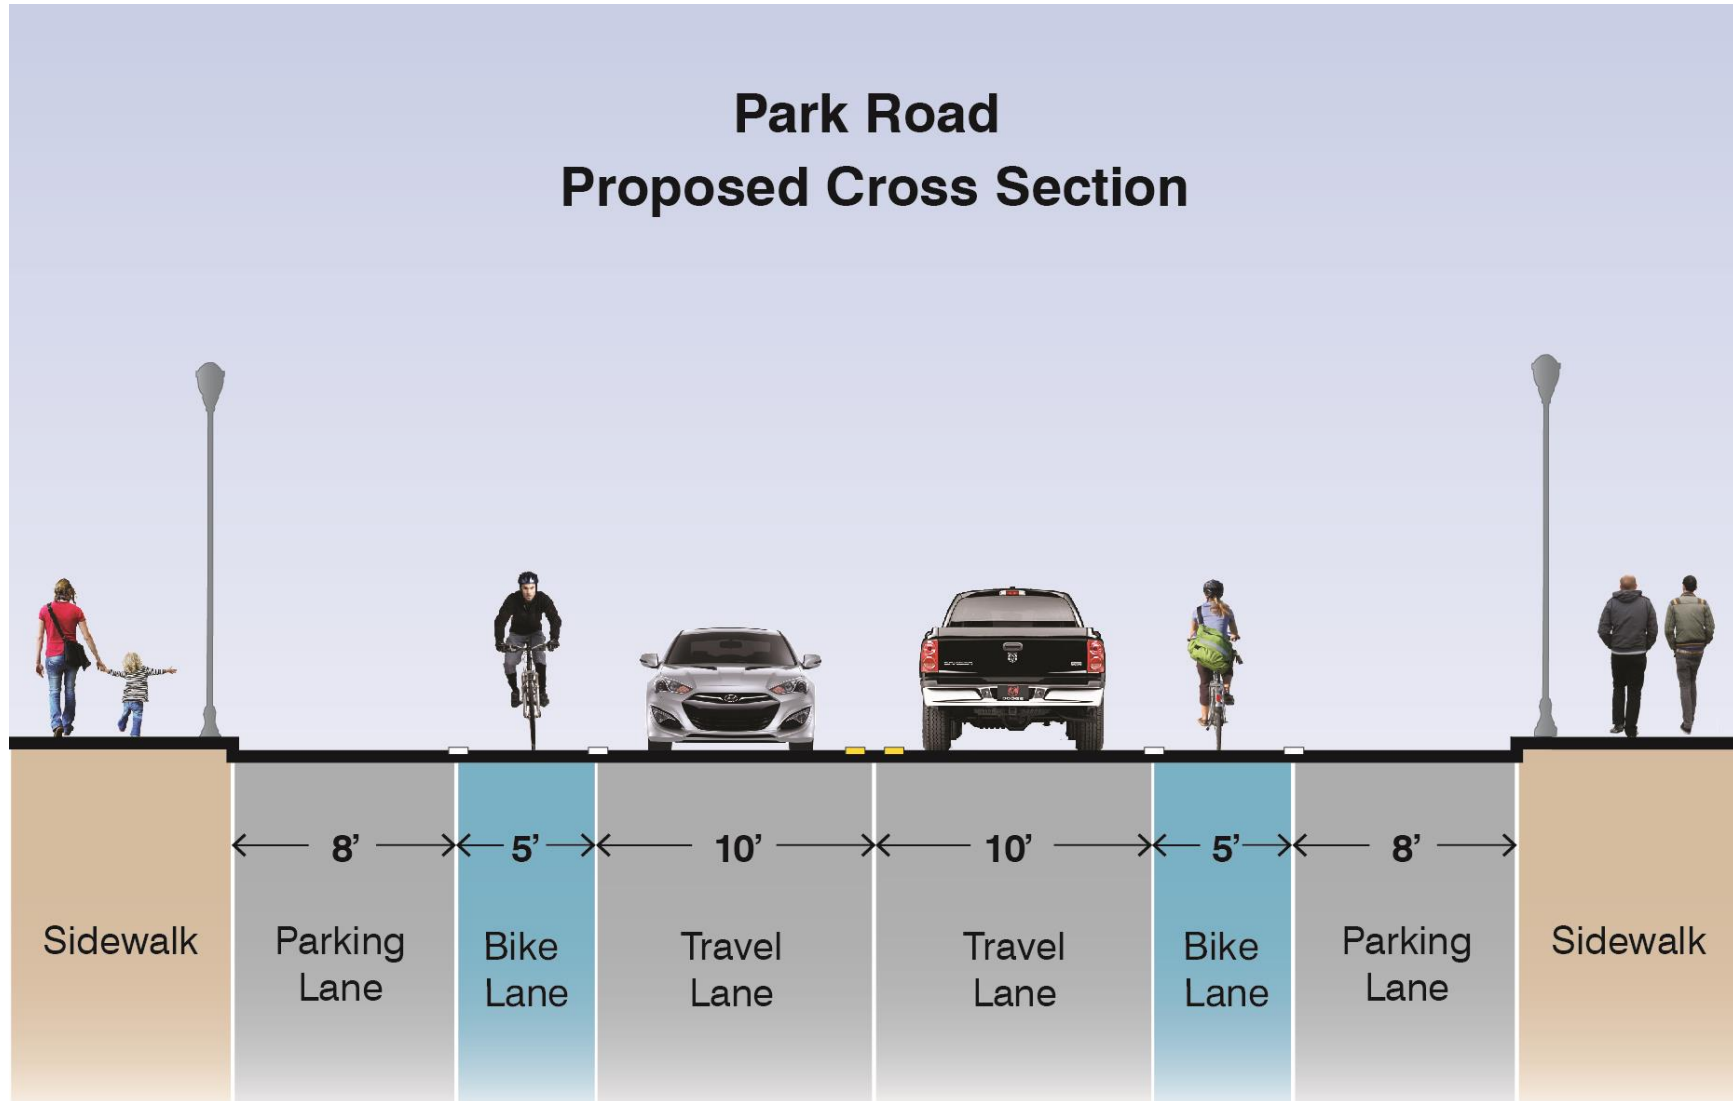
Exhibit 3-6: Cross section proposed for Park Road in the Study Area

- The existing curb-to-curb width of Park Road in the study area is 46-feet. This represents **the minimum width recommended to support on-street bicycle lanes, travel lanes and parking on both sides of the street**. An 11-foot travel lane would be more typical on main roads with regular usage by large vehicles such as buses and trucks. However, the 10-foot travel lane that is recommended, in combination with a 5-foot-wide bike lane, provides a combined operational space of 15 feet for motor vehicles and bicyclists. Reduction of either the parking lane width (8 feet) or the bicycle lane width (5 feet) **is not** recommended as this would position a bicyclist closer to the door zone of parked vehicles. The proposed cross section for the study area is provided in Exhibit 3-6.

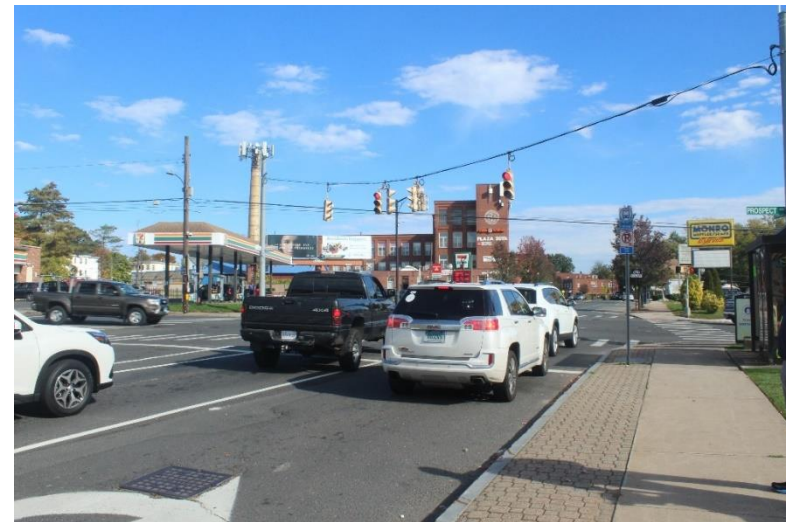
Exhibit 3-7: View of Park Road and Prospect Avenue looking east. Note right-turning vehicle overran stop line

- Curb ramps at crosswalks are expected to receive ADA upgrades such as tactile strips.
- Accessible Pedestrian Signal (APS) and pedestrian countdown signal heads are not installed at this intersection. These are expected to be included with the upcoming project.
- Dedicated right-turn lanes could pose a concern to pedestrians crossing the roadway if right-turning vehicles fail to stop at the stop line and overrunning crosswalk. See Exhibit 3-7.

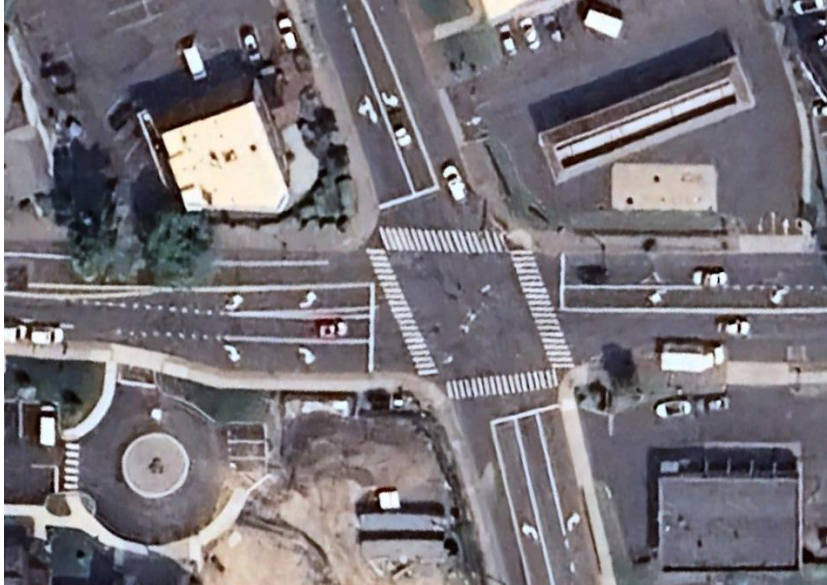
Exhibit 3-8: Existing lane configuration of the intersection of Park Road and Prospect Avenue. Note location of eastbound left-turn lane. (Source: Google Maps)

- The intersection was recently restriped to add dedicated left-turn lanes in the northbound, southbound, and eastbound direction. Previously, each of these approaches had two general purpose lanes.
- The eastbound left-turn lane is frequently encroached upon by turning vehicles such as northbound vehicles turning left and southbound vehicles turning right onto Park Road. See Exhibit 3-8.

- Relocate stop line for eastbound left-turn lane to west to reduce encroachment from turning traffic from Prospect Avenue.
 - This recommendation results in a “staggered” stop line similar to the eastbound approach at the intersection of North Main Street and Fern Street.
 - As an alternate to this recommendation, consider relocating the entire stop bar further to the west.

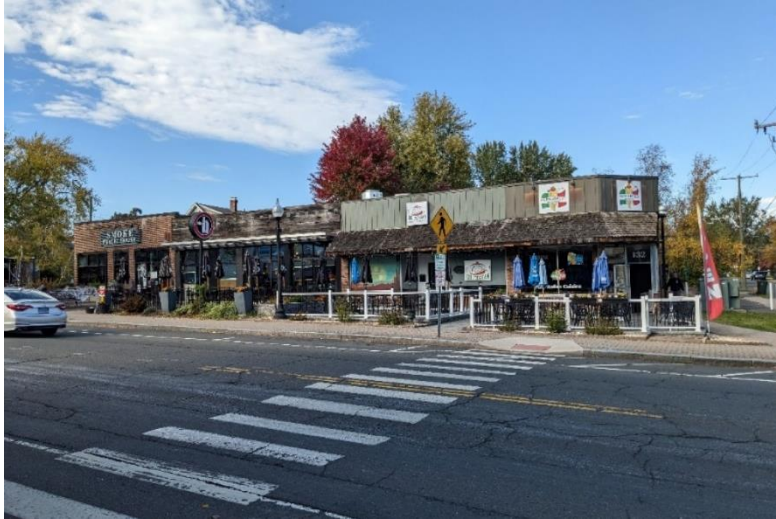
Exhibit 3-9: Crosswalk at Kingston Street looking north

- A crosswalk was previously considered at South Highland Street by the Town. RSA participants noted this would be a good location for a crosswalk due to connectivity to the north. Ideally, this would be on the east side of South Highland and connect to the west side of Ringgold Street. Bumpouts would be required to make this configuration feasible.
- The crosswalk at Kingston Street was installed in 2018. Sightlines appear to be sufficient and this was found to be a good location. Lighting at this location was noted by RSA participants as poor. This location could be a good candidate for bumpouts and an RRFB upgrade with high-intensity crosswalk lighting. Refer to Exhibit 3-9.

- Restripe edge lines between South Highland Street and Prospect Avenue (currently in progress by town).
- Install crosswalk, bumpouts, and RRFB with high intensity crosswalk lighting at the intersections of South Highland Street and Kingston Street. Refer to Exhibit 3-15 and Exhibit 3-16 for examples of an RRFB. See Exhibit 3-14 and Exhibit 3-17 for a concept layouts.
- Restrict parking on southeast corner of Park Road and South Highland Street within **50-feet** of the intersection. While this restriction exceeds state law, the existing on-street parking was found to obstruct sightlines. This

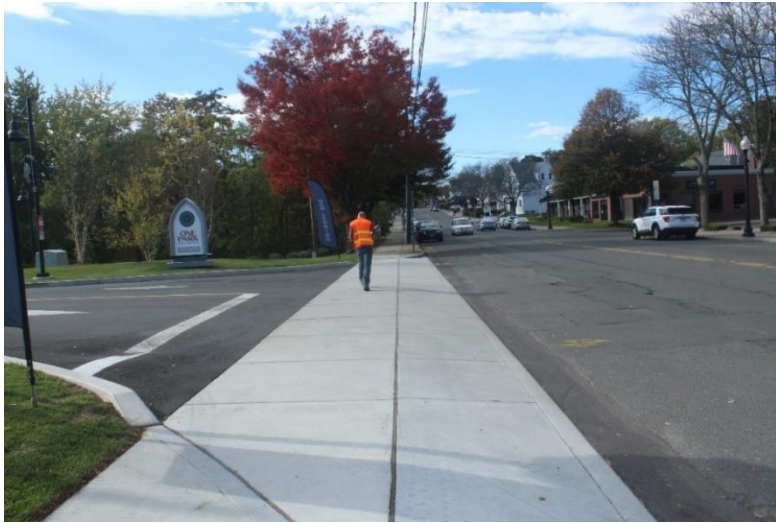
Exhibit 3-10: Driveway to One Park Road which measures approximately 70-feet

- The driveway to One Park Road was noted as excessively wide, resulting in a pedestrian crossing of approximately 70-feet. This is similar to the crossing distance to cross Park Road at the intersection of Prospect Avenue. See Exhibit 3-10.
- The driveway of 48 Park Road (car wash exit) is very wide at approximately 60-feet. This could be narrowed while accommodating the existing vehicular traffic patterns. See Exhibit 3-11.

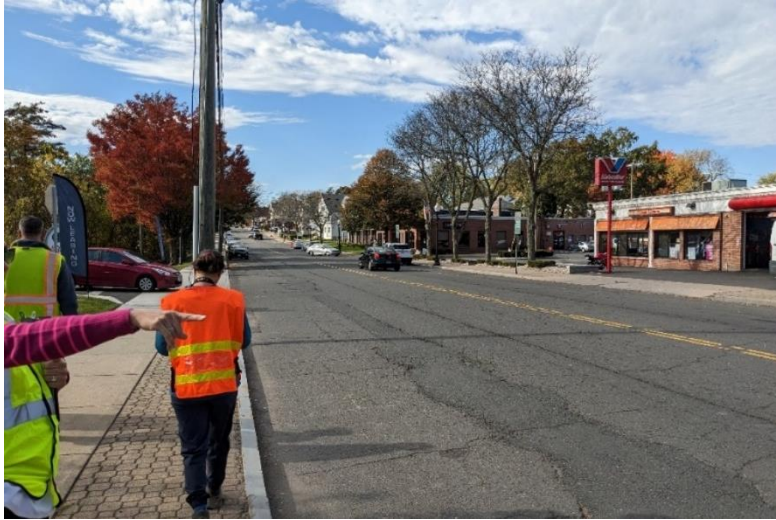
Exhibit 3-13: View of Park Road looking west towards the intersection with South Highland Street

- Pavement markings between Prospect Avenue and South Highland Street are in very poor condition or not present. This area is perceived as especially wide due to relatively limited on-street parking demand and no edge lines. Refer to Exhibit 3-13.

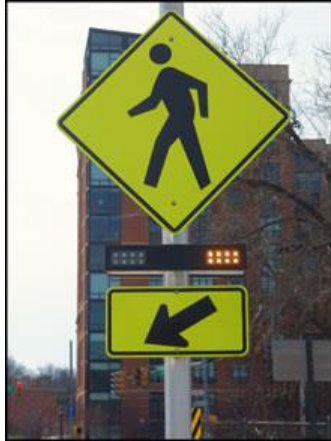
Exhibit 3-15: An example of RRFB (Source: CTDOT)

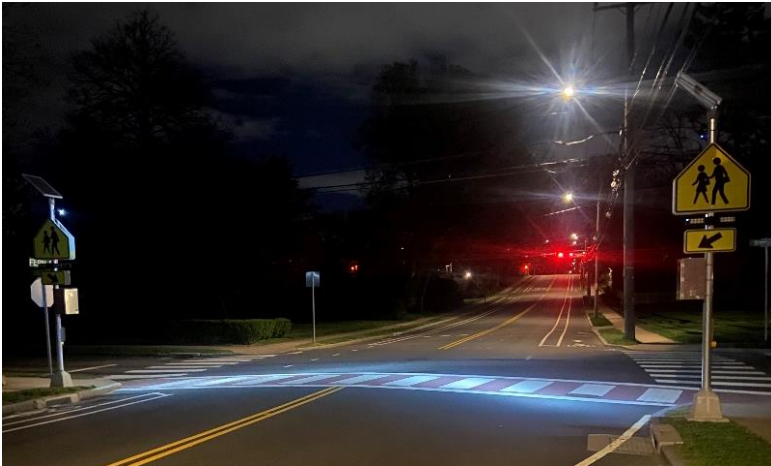
Exhibit 3-16: An example of a crosswalk high intensity light integrated with an RRFB at night on Fern Street. Note – The yellow flashers are not activated in this photo to demonstrate the crosswalk light

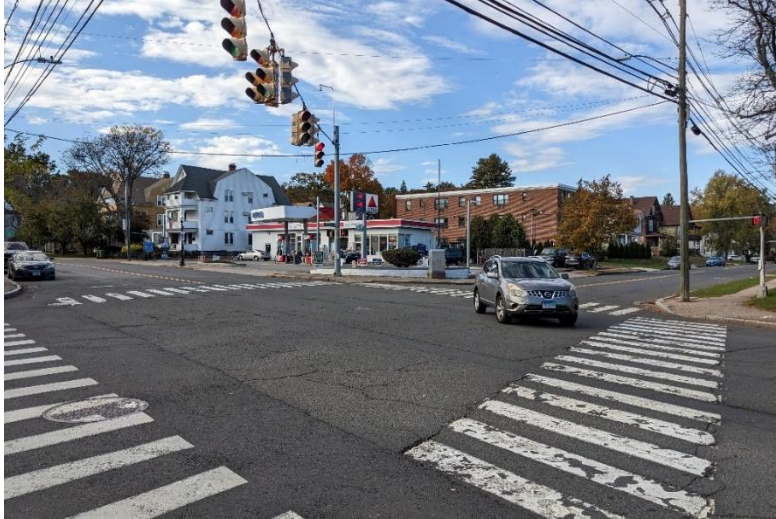
Exhibit 3-18: View of Park Road intersection with Oakwood Avenue. View looking northwest

- Vehicles were noted as parking too close to the intersection, and obstructing sight lines to crosswalks.
- The southbound approach lane is approximately 18-foot wide. The width of this lane can encourage vehicles to double-up or pass, which was of concern to some RSA participants.
- The CITGO gas station has three driveways of significant width. This may be an area for access management.

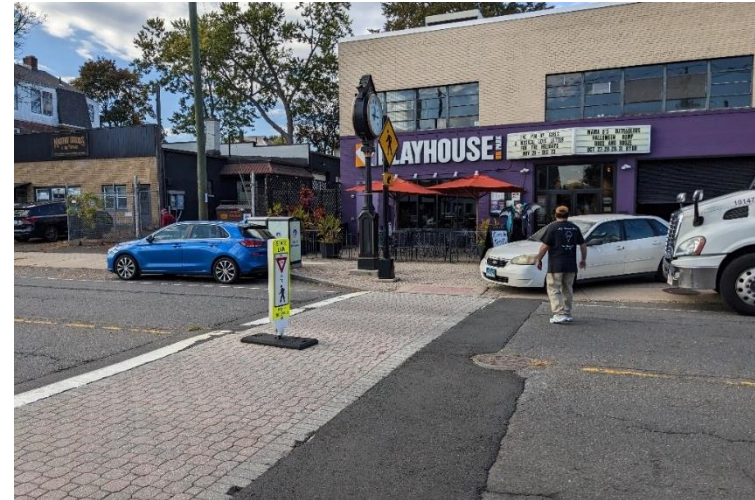
Exhibit 3-20: Crosswalk west of Nesbit Avenue at Playhouse on Park. View looking north.

- The crosswalk just west of Nesbit Avenue (across from Playhouse on Park) is well utilized by patrons of area businesses. However, the visibility to the crosswalk was noted as a concern due to parking and truck-loading right up to the crosswalk. The crosswalk is constructed of decorative brick but lacks crosswalk markings on the east side due to recent repaving. The effect of the decorative material was discussed as these materials offer less contrast over standard crosswalk markings during nighttime conditions. There is an actuated LED sign for the crosswalk, however this predates more modern, and highly visible RRFB systems. See Exhibit 3-20 and Exhibit 3-21 which shows this crosswalk and the concerns noted.
- The driveway to 247 Park Road (European Motors) appears to be unused. This property is served by two driveways on Nesbit Avenue as well.

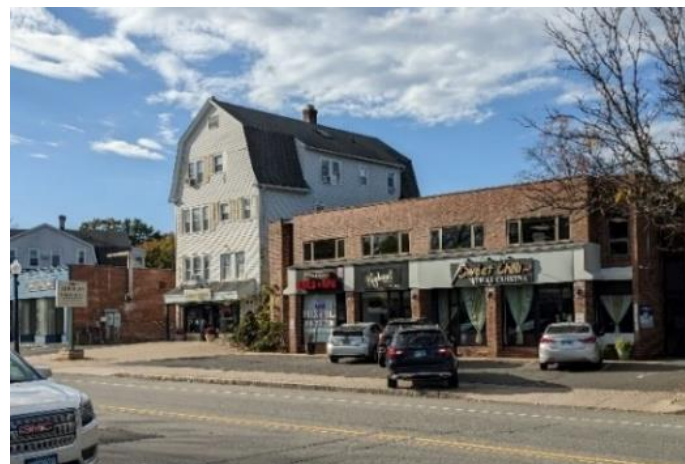
- The usage of brick pavers generally delineates the pedestrian space well, however, some properties have incorporated brick pavers for parking areas as well (e.g. 314 Park Road, at left of photo in Exhibit 3-23). The use of the same material for both sidewalk and parking in these locations is confusing in some cases for pedestrians and drivers alike who may not be able to distinguish between parking areas and sidewalk.

Exhibit 3-23: View of front parking at 312 Park Road and adjacent properties. Note vehicle maneuvering over curb and sidewalk out of parking space.

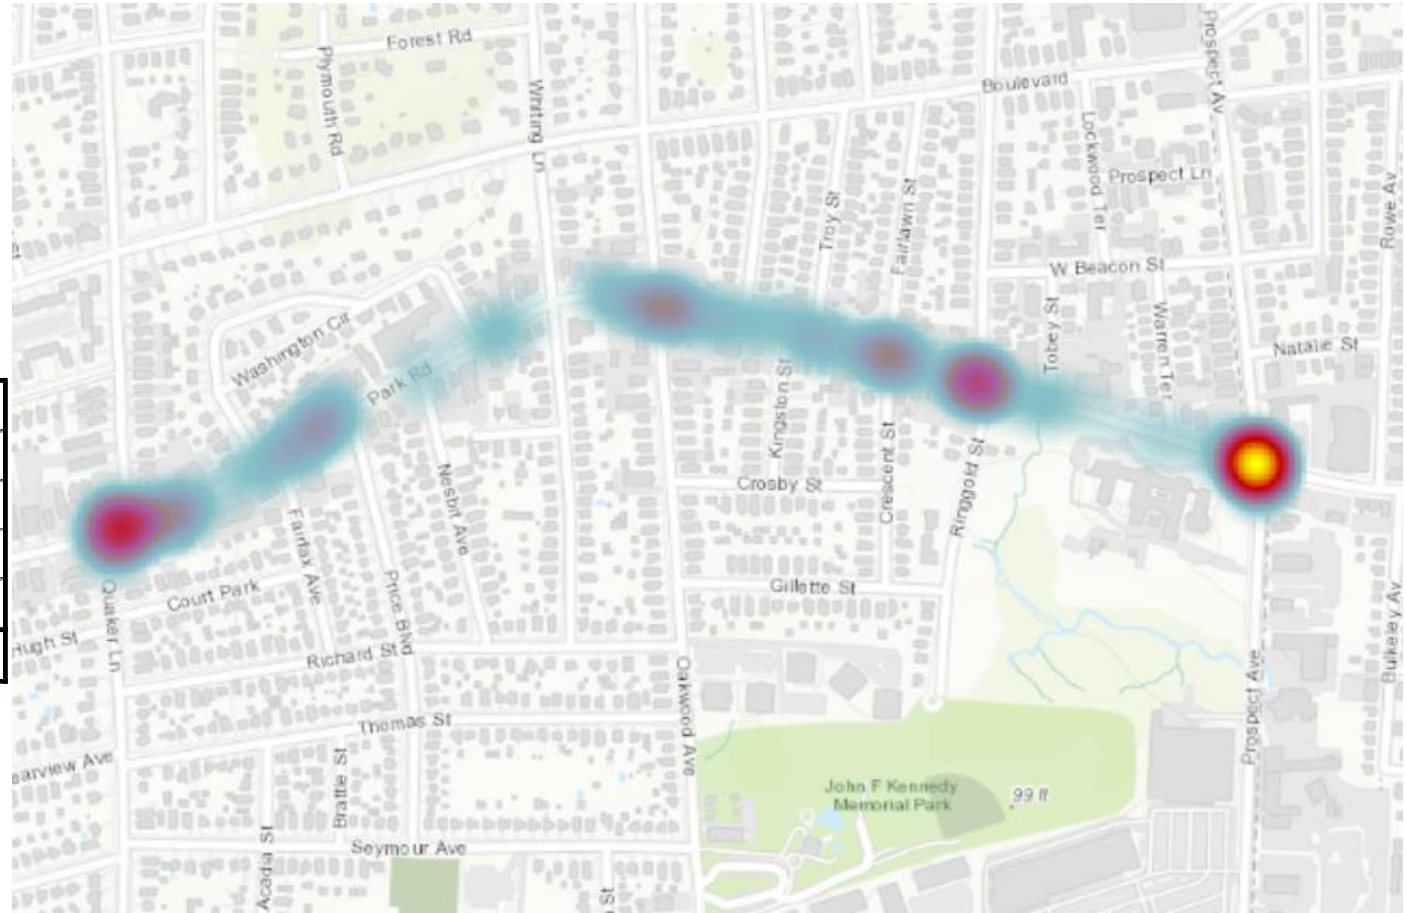
- Park Crescent, Highland & Tobey – 26 Crashes (16 injury + 2 serious injury)
- Park / Prospect – 39 crashes (17 injury)
- Park / Quaker – 29 Crashes (10 injury)
- Park / Oakwood – 14 Crashes (6 injury + 1 fatality)

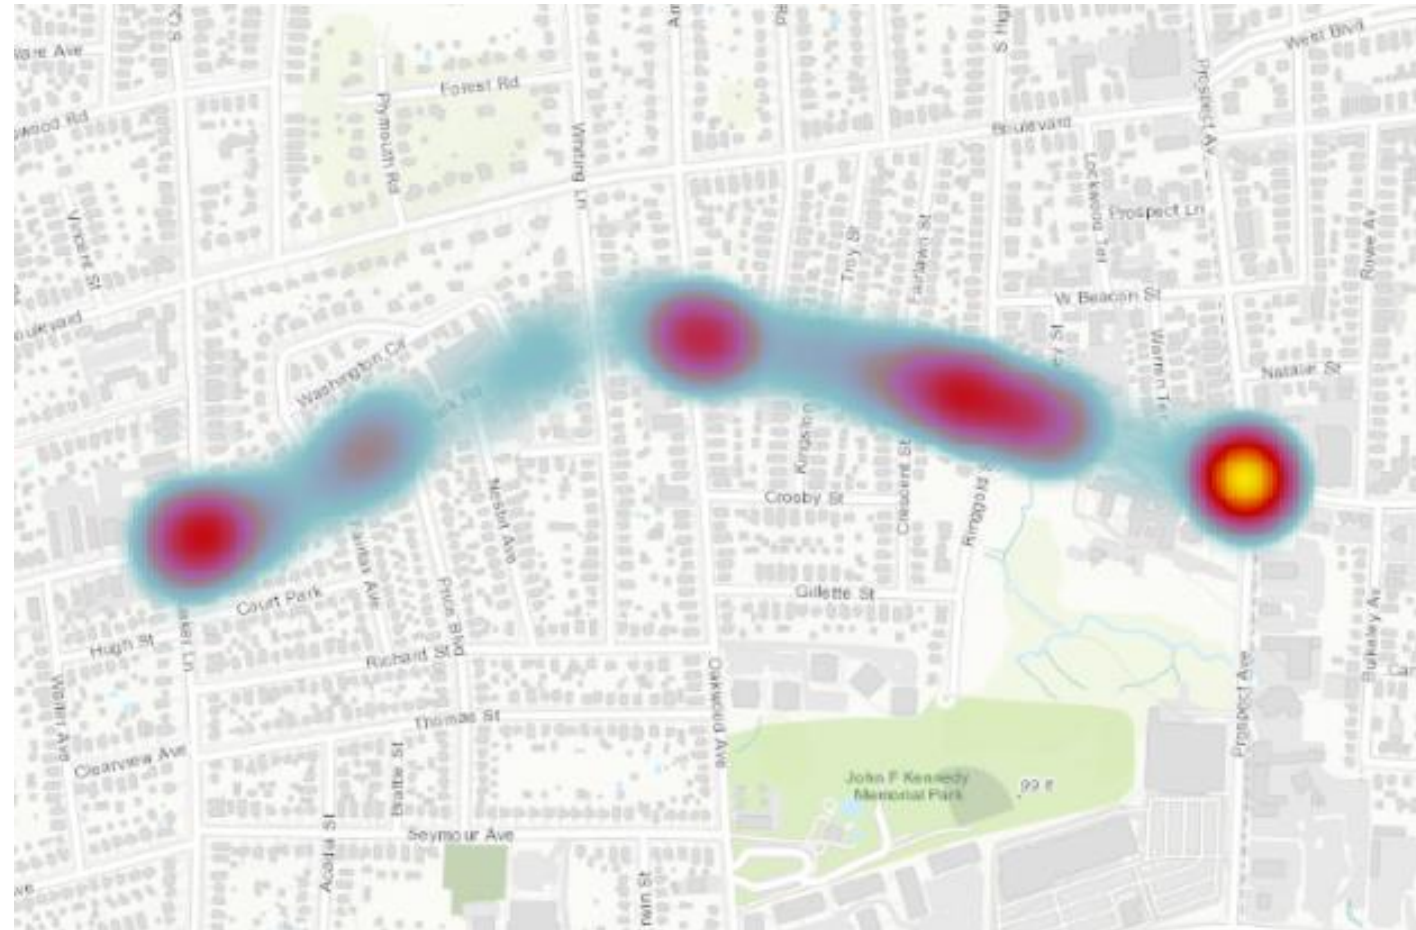
Weighted Heatmap (10x for KSI Crashes)

Park / Prospect – 39 crashes (17 injury)

- Angle crashes between left-turning vehicles (esp. Prospect)

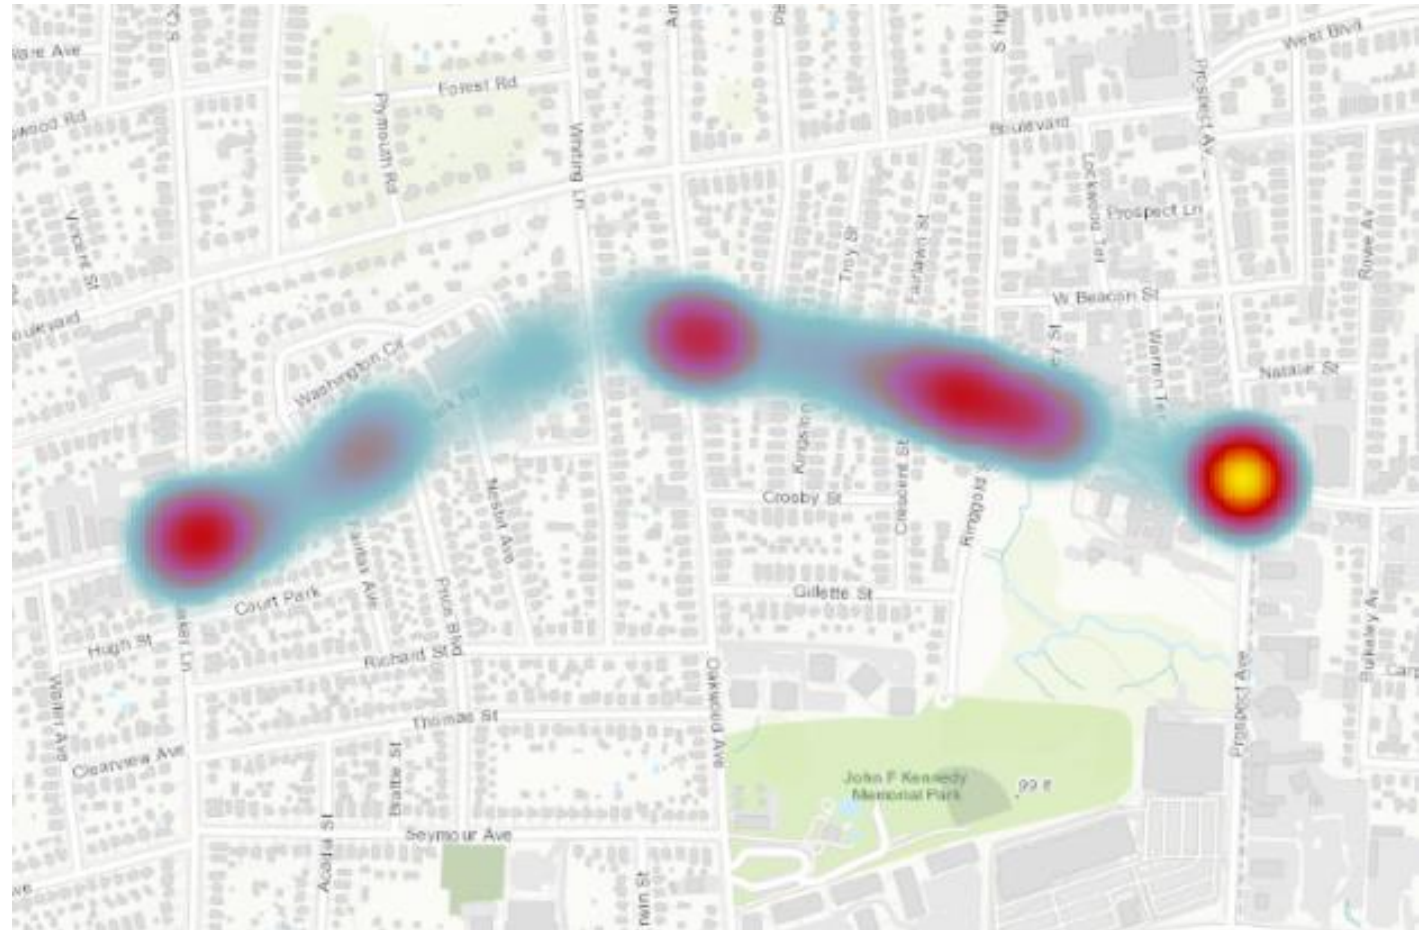
Weighted Heatmap (10x for KSI Crashes)

- There were 9 crashes involving pedestrians or bicyclists in the study area
- 4 crashes involving pedestrians resulted in minor injury
- 1 crash involving pedestrian near Oakwood Ave resulted in fatality

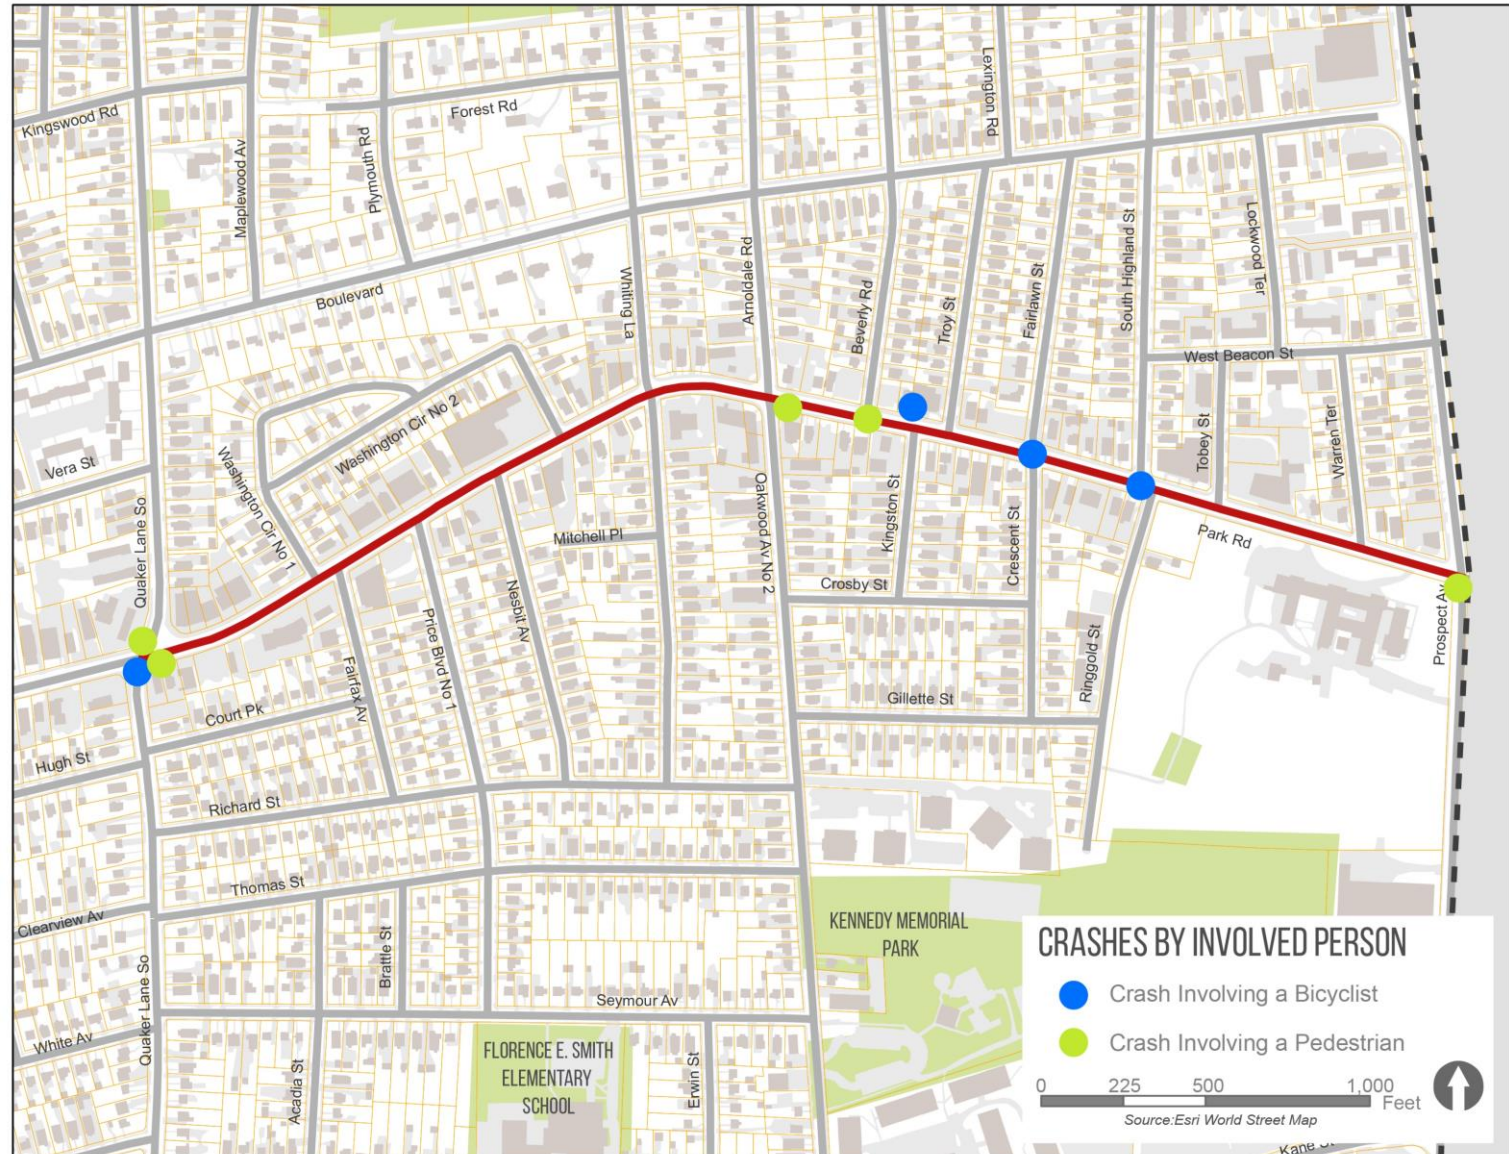
- Fatal Pedestrian Crash Park Road at Oakwood
 - December 16th, 2018 at 8 PM
 - Pedestrian crossing north of Park Road east of the crosswalk at intersection struck by eastbound motorist
- 4 Pedestrian Crashes Resulting in Injury
 - Park & Quaker – August 3, 2019 at
 - Pedestrian stuck in WB right-turn area. Driver issued infraction
 - Park & Quaker - June 7, 2018 at
 - Pedestrian struck in north-side crosswalk against signal
 - Park & Beverly – April 7, 2022 at 9:12 PM
 - Pedestrian struck by turning vehicle into Beverly
 - Park & Prospect – July 17, 2018 at 9:06 PM
 - Pedestrian struck crossing southern leg of intersection against pedestrian signal by westbound left-turning vehicle

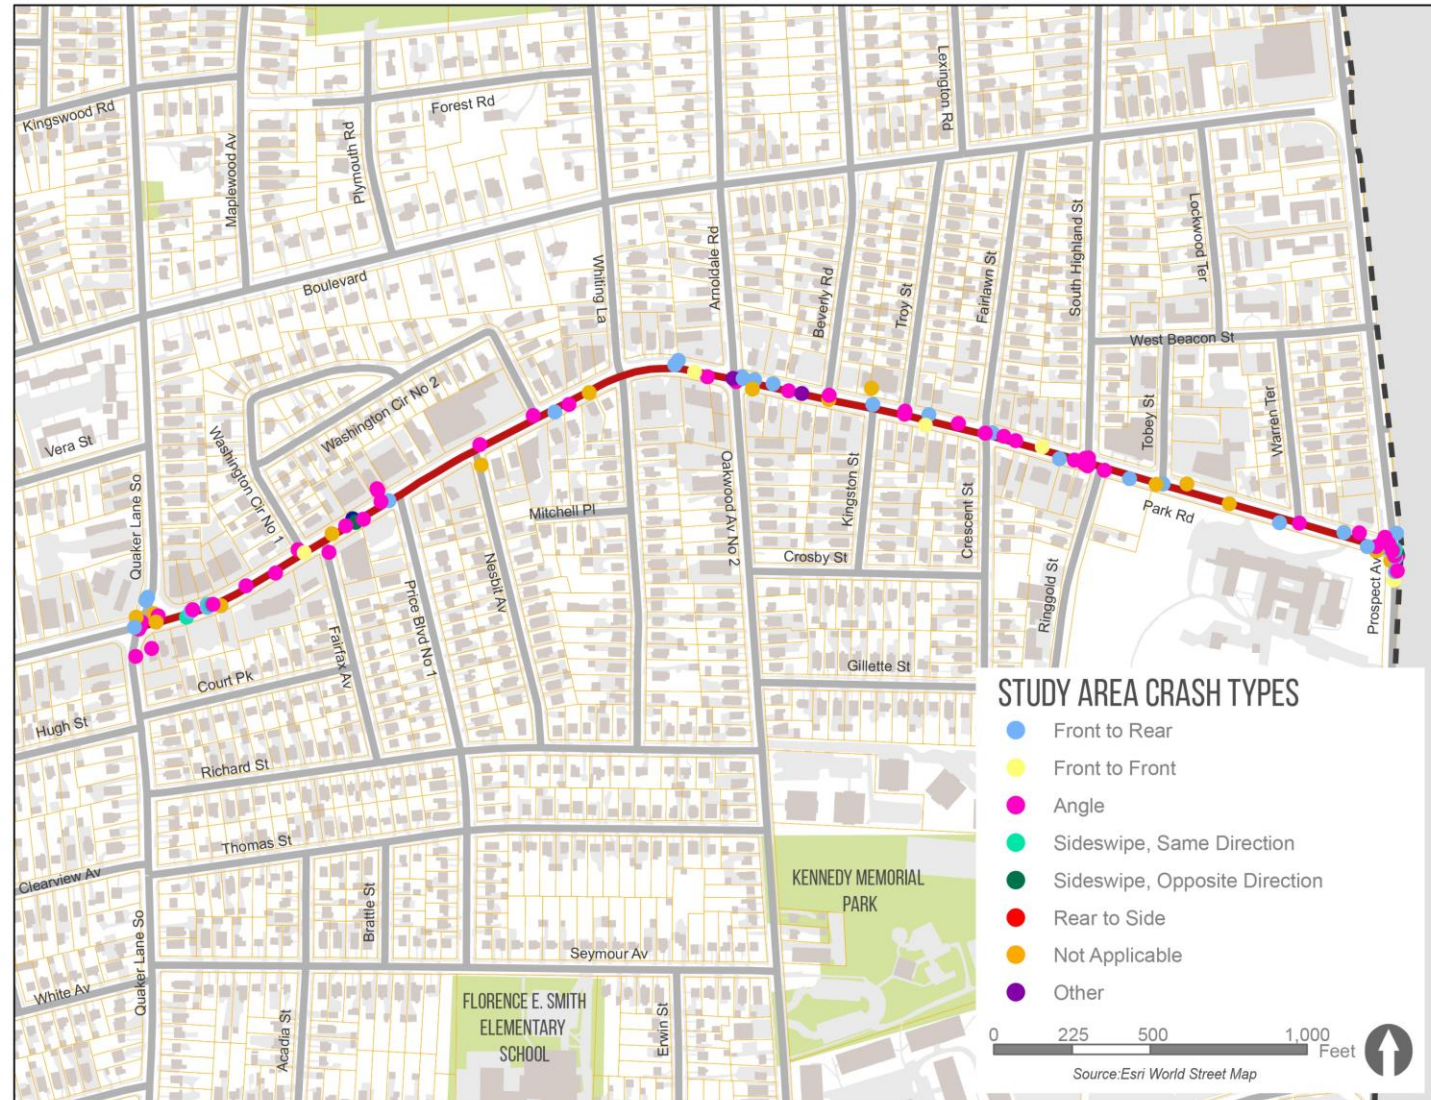
- Majority of crashes (80) are classified as No Apparent Injury- Property Damage Only
- There was one crash resulting in fatality
 - Park Road east of Oakwood Ave
- Two crashes resulting in serious injury
 - Park Road east of Crescent
 - Park Road at Tobey Street

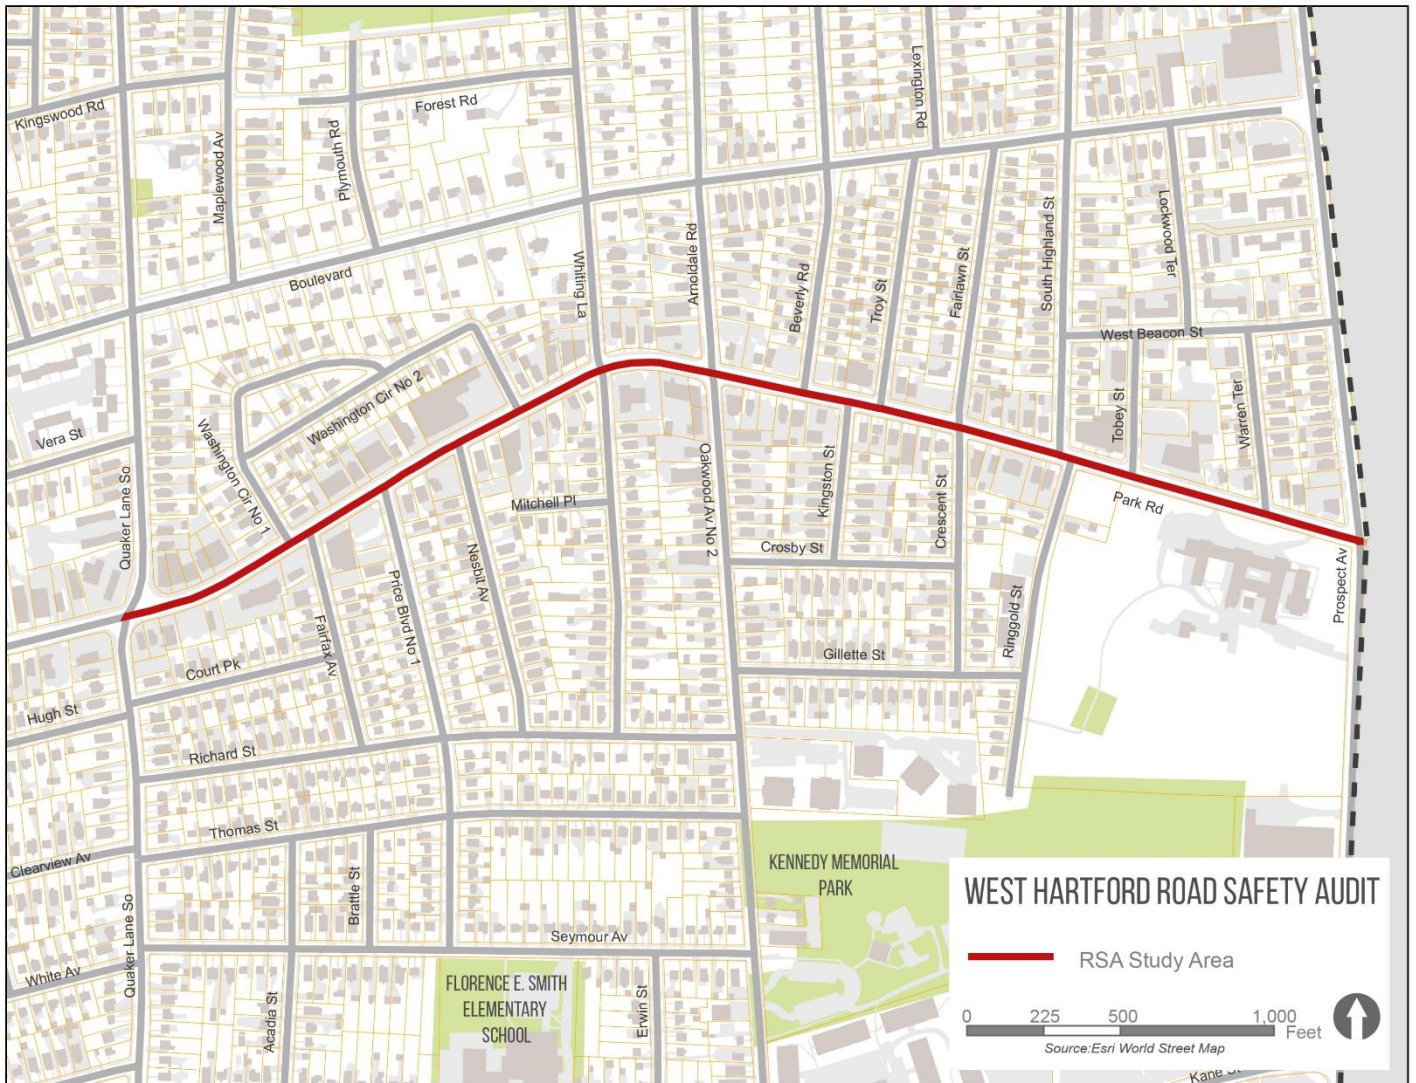
Road Safety Audit - Study Area

- Park Road between Prospect Avenue and Quaker Lane
